Subject: Weekly Monitoring Report for Week Ending 06/08/2019
Florence Copper, Production Test Facility
Aquifer Protection Permit No. 106360, LTF 61845

Florence Copper is submitting this report in accordance with Table 4.1-8 and Section 2.7.4.4 of the Production Test Facility Temporary Aquifer Protection Permit (APP) No. 106360.

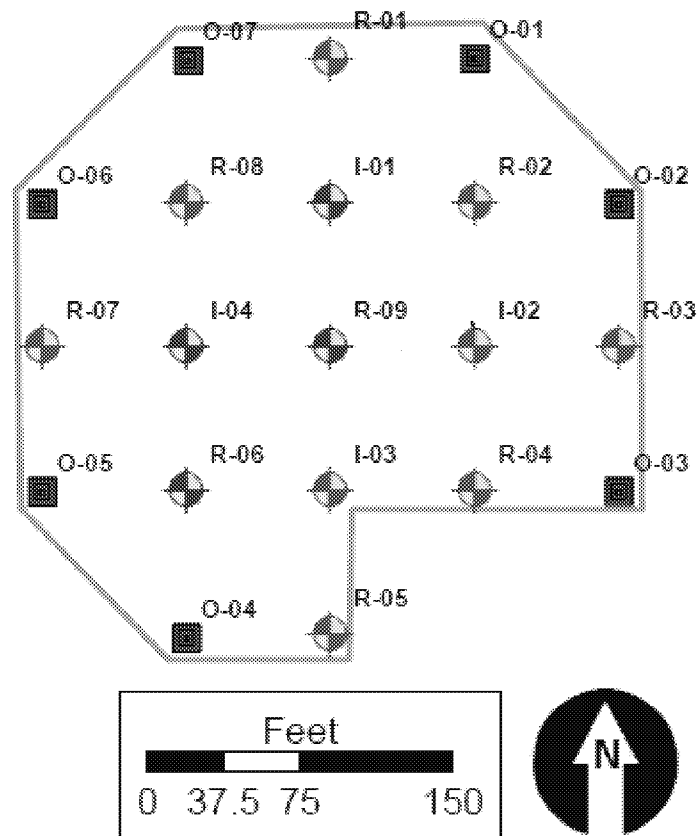
A map showing the location of the PTF injection, recovery, and observation wells is included as Figure 1.

Figure 1. PTF injection, recovery, and observation well locations

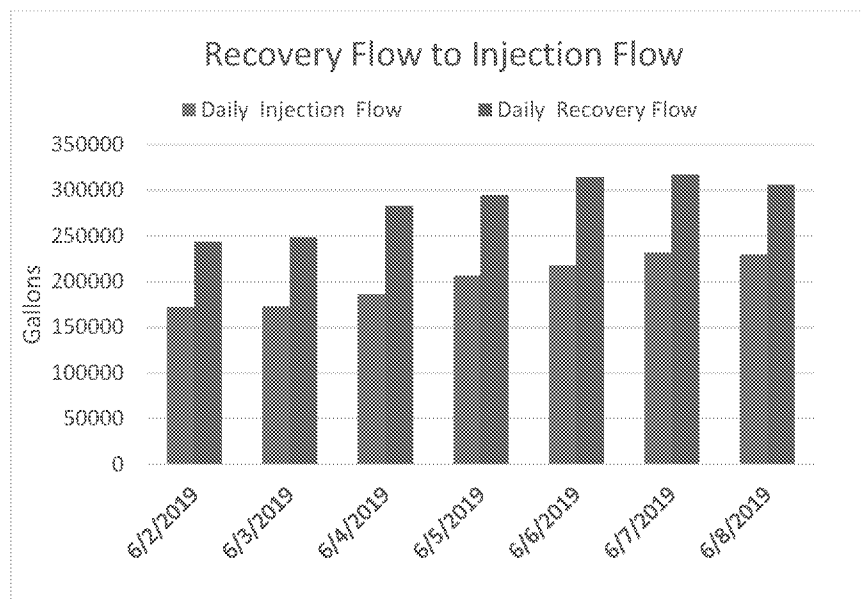
A summary of the injected and recovered volumes for the week 06/02/2019 to 06/08/2019 is included in Table 1. The total injected and recovered volumes for the PTF as a daily total are also presented on Figure 2. Recovery well R-09 was taken out of service for maintenance of well screens, and flows were adjusted to maintain hydraulic gradient.

During the reporting period no exceedance of the alert level was measured for recovered volume to injected volume. The alert level is the recovered volume shall exceed the injected volume.

Figure 2. Recovered volume to injected volume

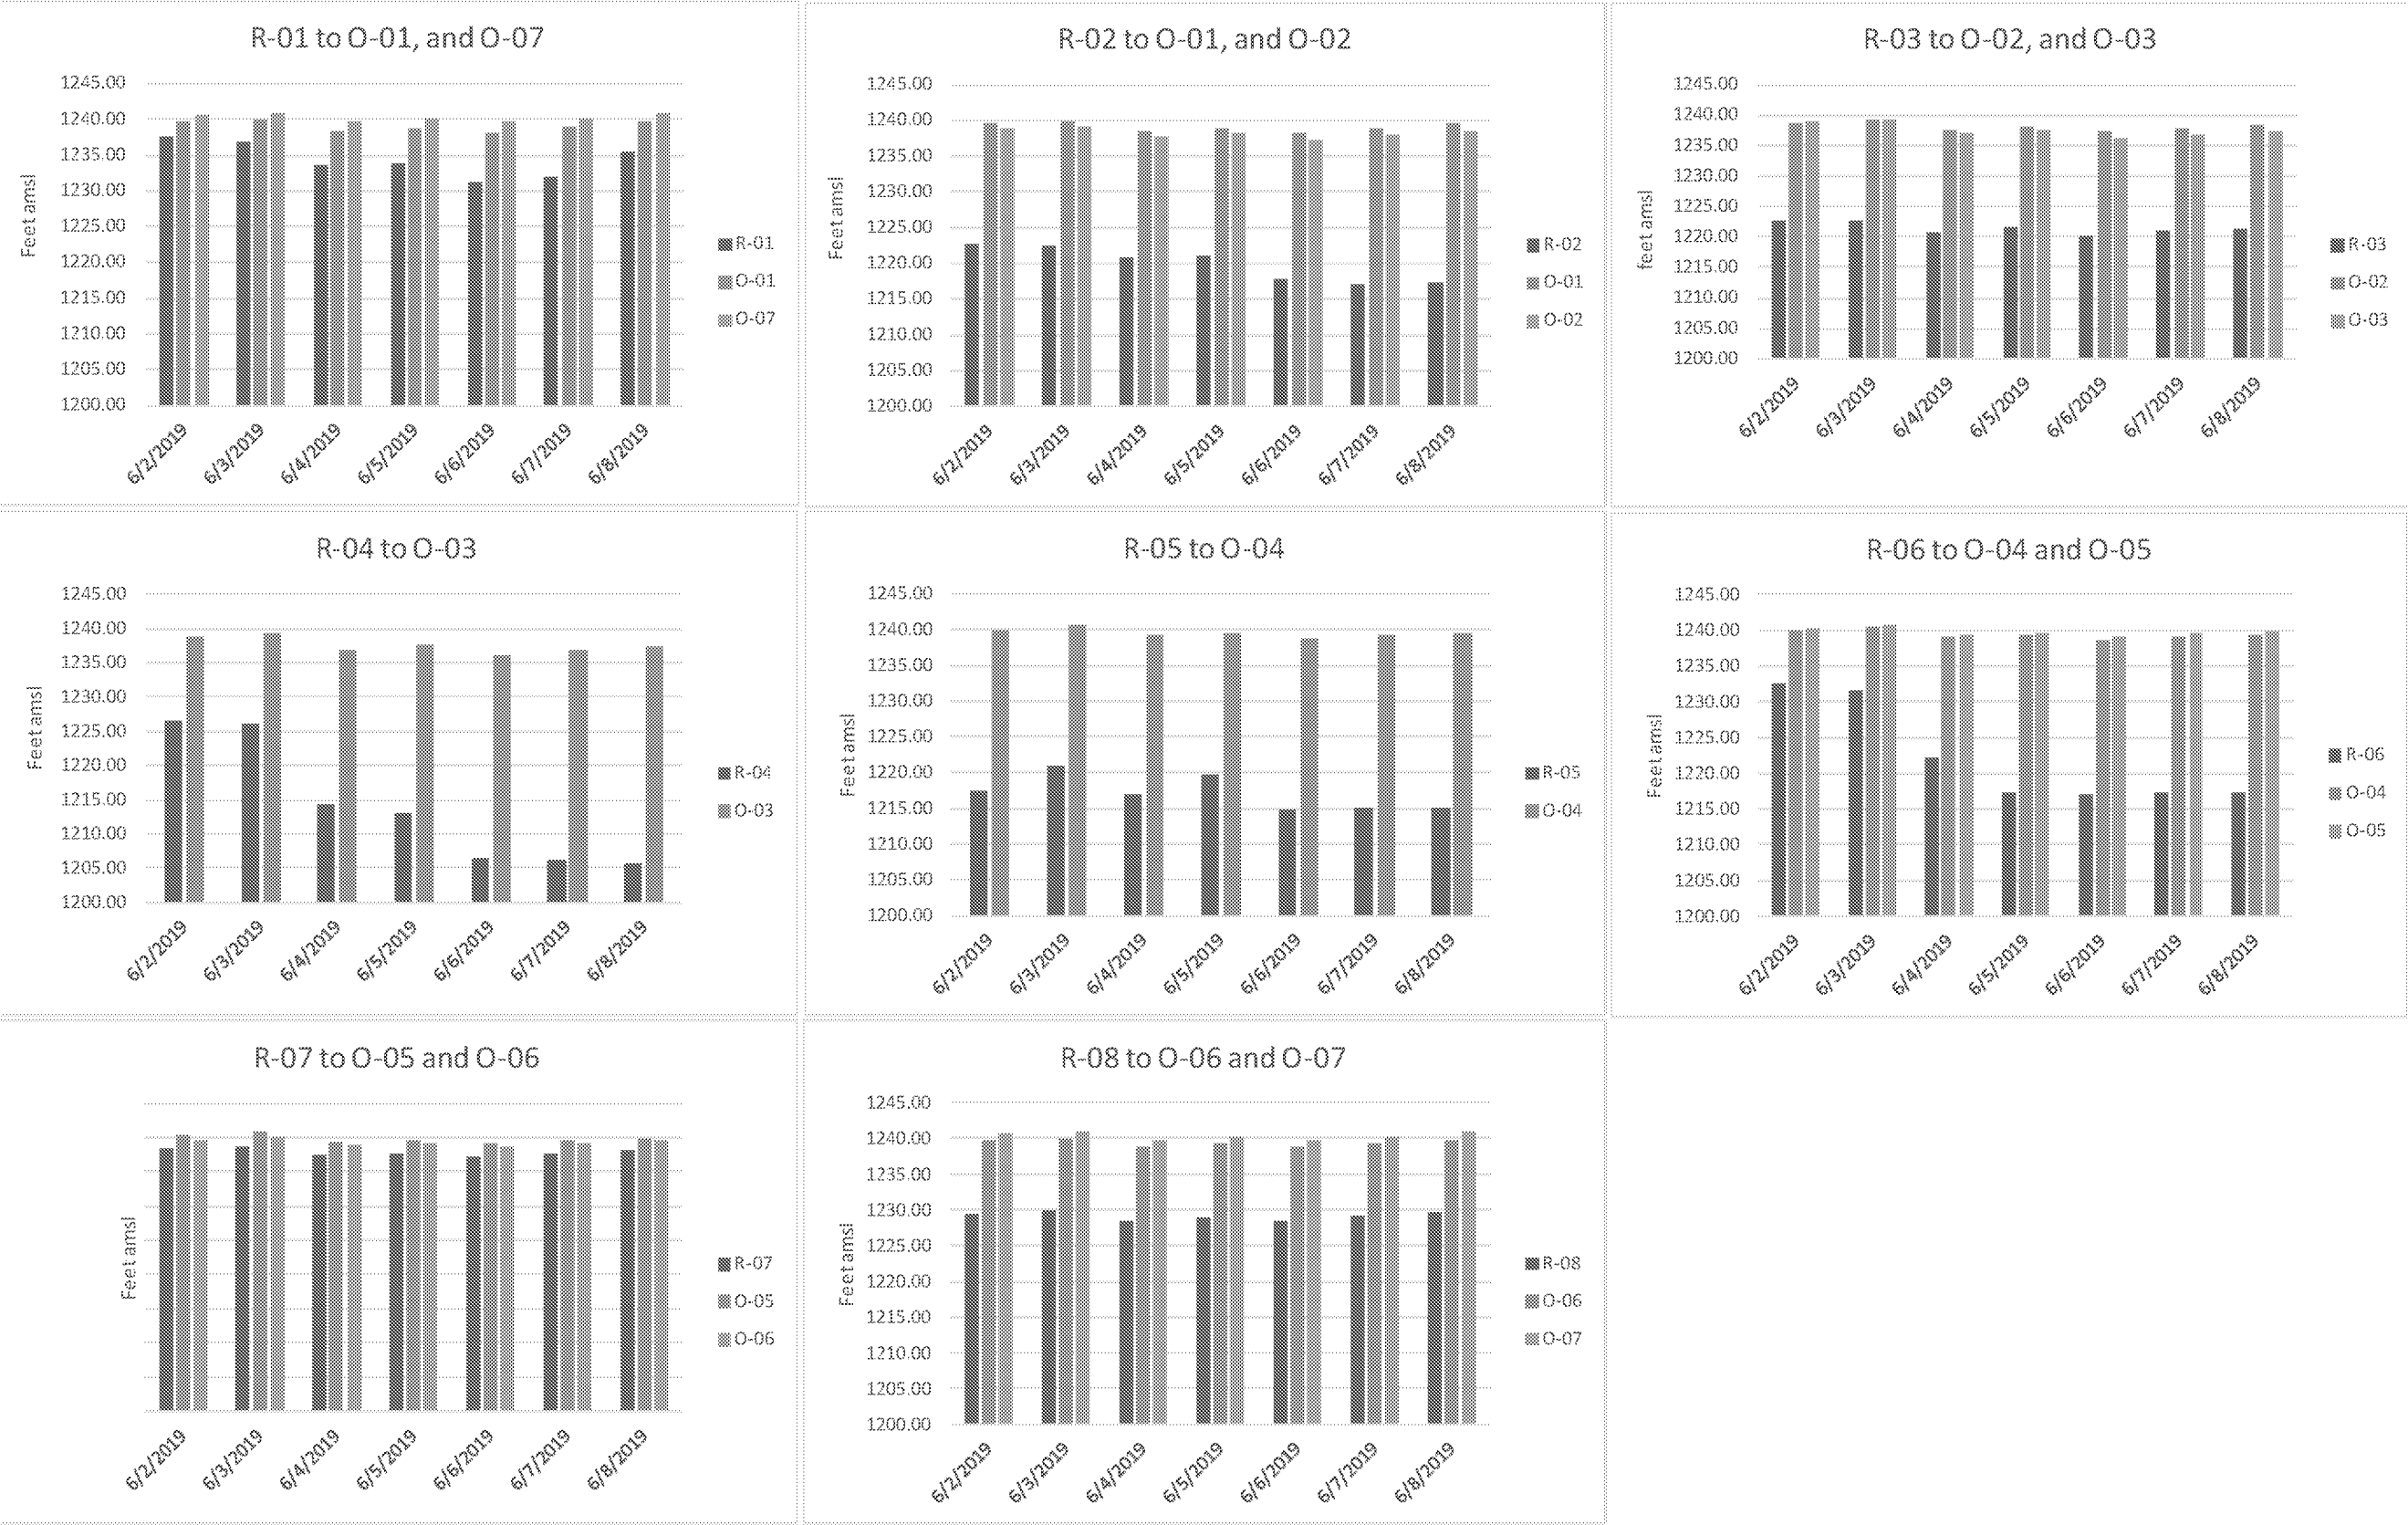
Figure 3

Table 2 includes a summary of water levels in the recovery and observation well pairs. Hydrographs showing the water level elevation for each recovery well and observation well pair are included in Figure 3.

During the reporting period, there was no exceedance of the alert level for the inward hydraulic gradient. The alert level for the inward hydraulic gradient is that the water level elevation in the paired observation well must be a minimum of 1 foot higher than the paired recovery well.

Figure 3. Recovery and observation well pairs
